Post Remedial Action Report Lansdowne Radioactive
Residence Complex Dismantlement/Removal Project

June 1990

**Department of the Army
Baltimore District Corps of Engineers**

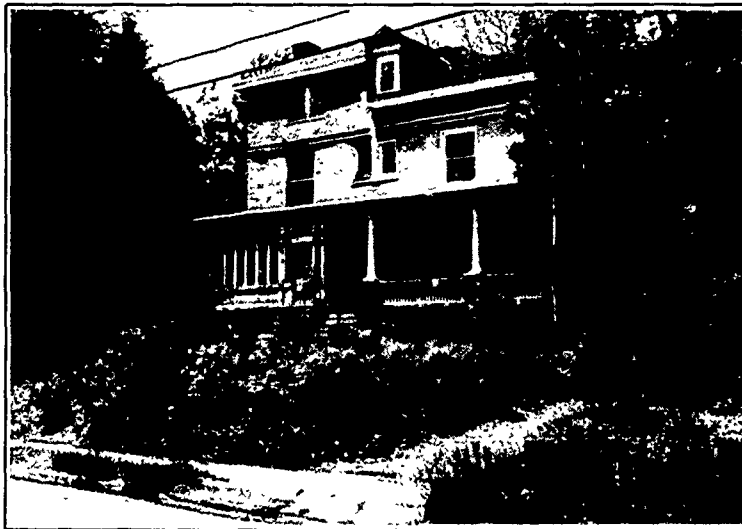
Fig. 2:1 - Contaminated Residence at 105/107 E. Stratford Ave.
The glassed-in front porch is on the 105-side. The open front porch is on the 107-side. The photo was taken facing northwest, before start of site remediation. August, 1988.

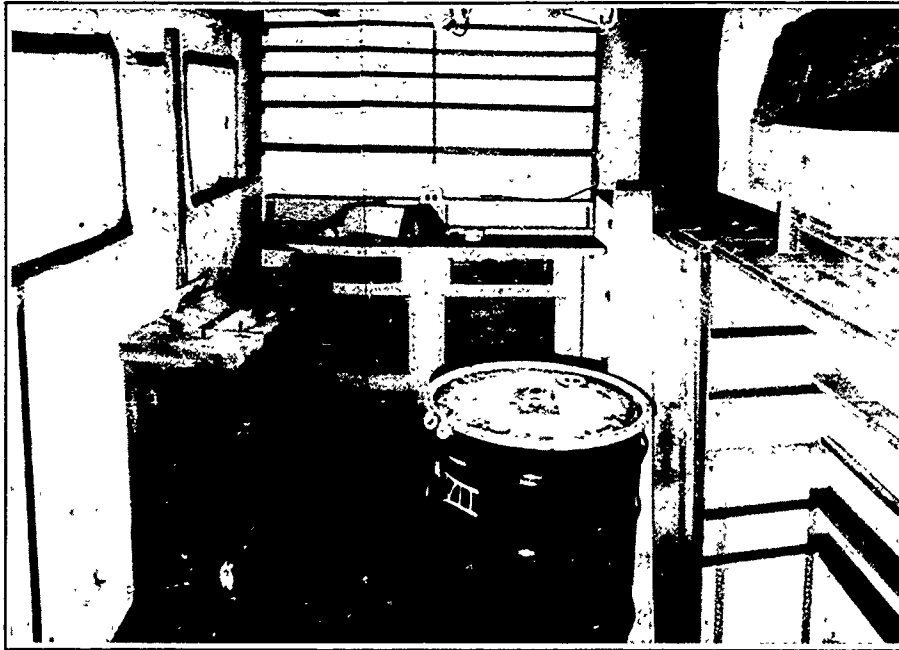
Fig. 2:2 - Former Radium Processing Room in the Basement of the 105 Residence. The metal drum in the foreground contains radioactive waste left behind from EPA's 1984/85 Emergency Removal Action. There were eleven such drums filled mostly with household chemicals, and they posed a special disposal problem. They could not be sent directly to a radioactive disposal site because they contained both known and unknown chemical liquids. On the other hand, they could not be disposed of at a chemical disposal site because the contents were radioactive. For that reason, they were left in the basement for disposal by the contractor who would later dismantle the house. Photo was taken facing east toward the masonry wall separating the 105 and 107 residences. August, 1988.

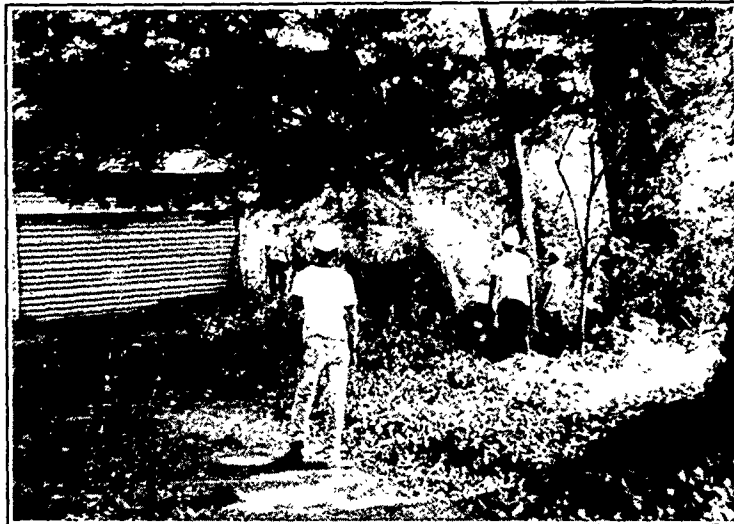
Fig. 5:1 - Tree Clearing.

28 tons of trees and brush were cleared from the site and disposed of in a sanitary landfill. The roots and stumps, however, were contaminated with radioactive soil and had to be disposed of as rad-waste. Testing determined that there was no uptake by vegetation of radioactive contaminants in the soil. August, 1988.

- (1) Qualifying personnel for work in the radiation-controlled zone.
- (2) Clearing the site of trees and shrubs, and construction of the security fence (Fig. 5:1).
- (3) Setting up the jobsite administration area (Figs. 5:2, 5:5 and 5:6).
- (4) Setting up continuous air monitoring stations along the site perimeter (Fig. 5:3).
- (5) Establishing containment and HEPA ventilation inside the house (Fig. 5:7).

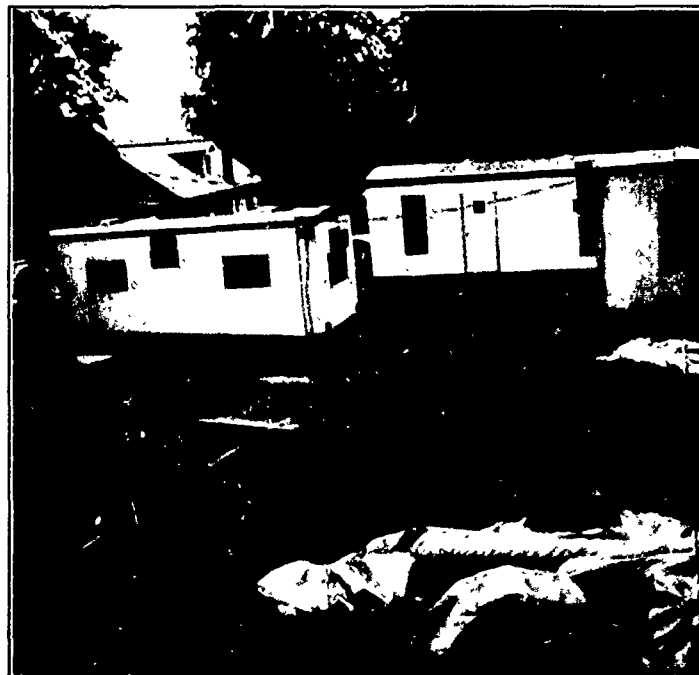
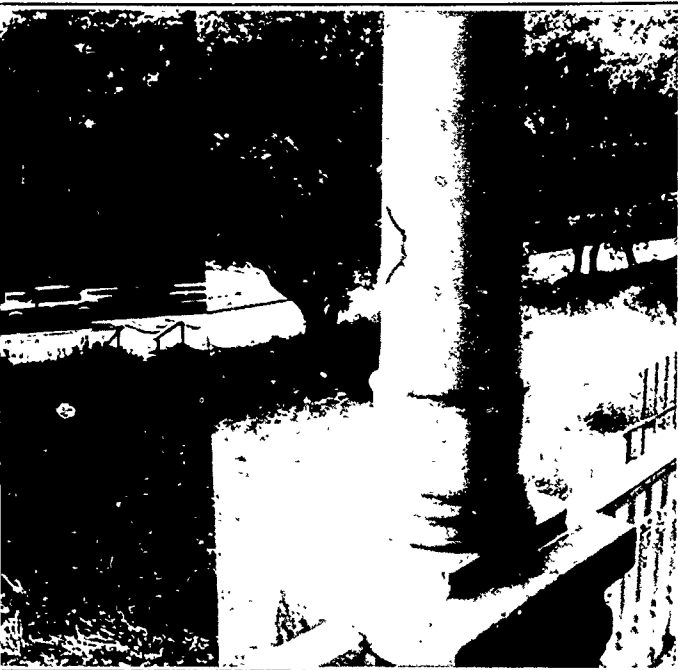
Fig. 5:5 - E. Stratford Ave. Residential Neighborhood Prior to Jobsite Mobilization.
Photo taken facing south from the front porch of the 107 residence.
July, 1988.

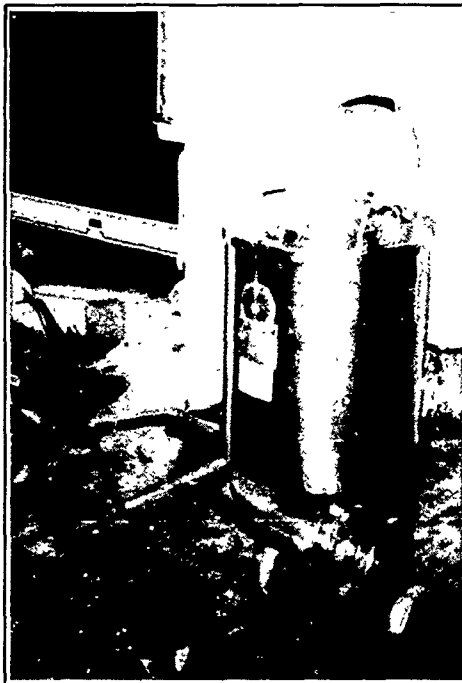
a. 500 cfm HEPA unit in upper-level room about to undergo interior dismantlement.

During dismantlement of the house, the Contractor elected to use the building itself as a containment structure to prevent the release of radioactive particulates into the environment. This involved first sealing all doors and windows with flexible plastic sheeting and duct tape. A small (500 cfm) HEPA vacuum unit was then activated in the upper-level rooms of the house where dismantlement was underway. The 500 cfm HEPA's on the upper floors exhausted filtered air through a duct passing through a hole in the floor down to the first floor living room. The air exhausted into the first floor living room was then drawn through a duct passing through a window to the main (2000 cfm) HEPA unit located outside the house on the 107 front porch. The main HEPA unit filtered the air again before exhausting it into the atmosphere. A CAM (Continuous Air Monitoring station) was placed beneath the exhaust port of the main HEPA to verify that all air from inside the house that was being exhausted into the environment contained no radioactive particles. August, 1988.

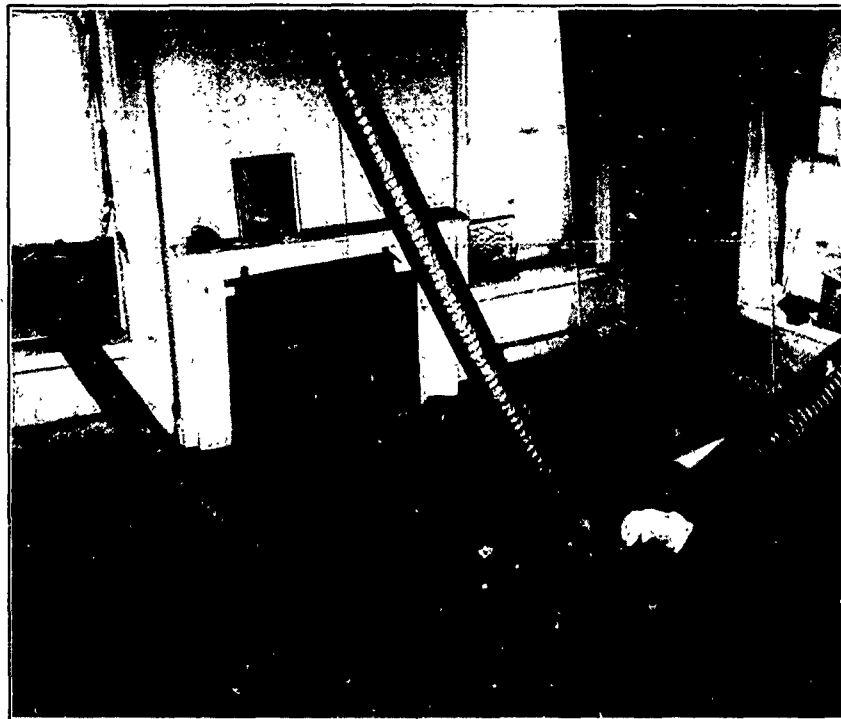
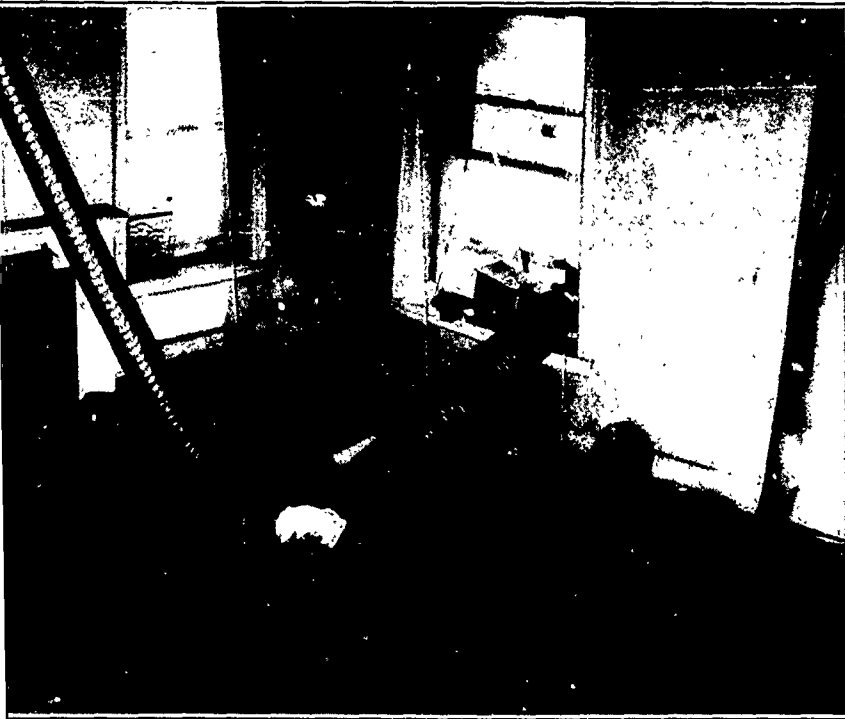
c. First floor living room into which HEPA filtered air was exhausted from rooms on the upper level undergoing interior dismantlement. Duct passing through window at right draws filtered air to the main 2000 cfm HEPA unit located on the porch outside the house.

HEPA filtered air was exhausted from rooms on the upper levels of the house. Duct passing through window at right draws filtered air exhausted into the room cated on the porch outside the house.

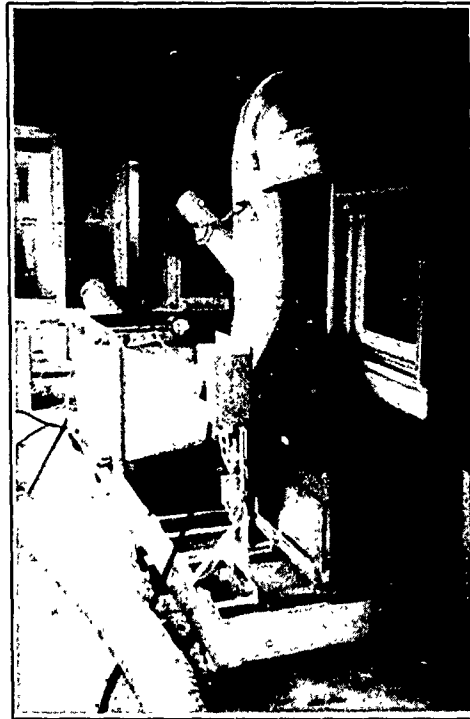
Fig. 5:7 - HEPA Ventilation System.

Fig. 5:7 - HEPA Ventilation
During dismantlement to prevent the release of contaminants from the upper-level rooms, the exhausted filtered air from the 500 cfm HEPA unit is exhausted into the first floor (2000 cfm) HEPA unit before exhausting it in the exhaust port of the main environment containment system.

d. Main 2000 cfm HEPA vacuum located on the 107 front porch outside the house.

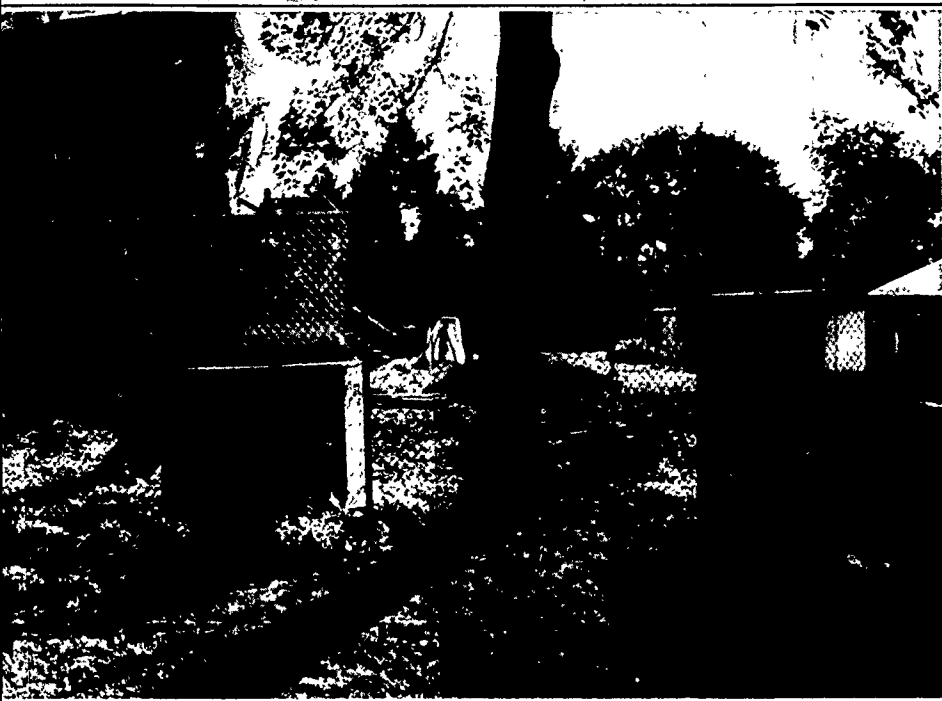
Fig. 6:1 - Jobsite Facing East from 99 E. Stratford Ave., Prior to Exterior Building Dismantlement. August, 1988.

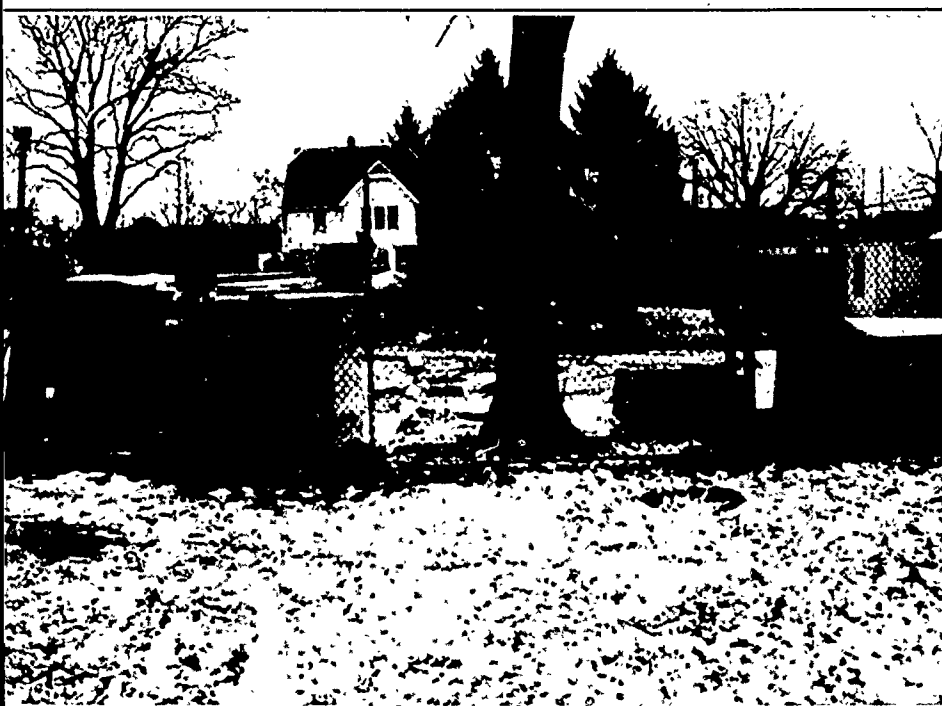
Fig. 6:2 - Jobsite Facing East from 99 E. Stratford Ave., After Exterior Building Dismantlement Down to the Basement Ceiling. December, 1988.

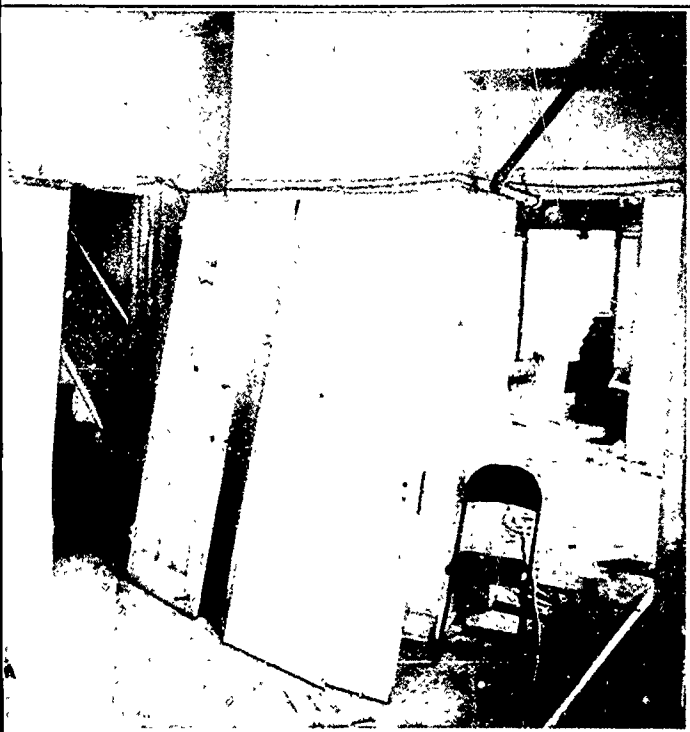
Fig. 6:3 - First Floor, 105 Side, Prior to Interior Dismantlement.

Photo was taken standing in the kitchen facing south through the dining room and into the living room. The front door of the house is in the far background. August, 1989.

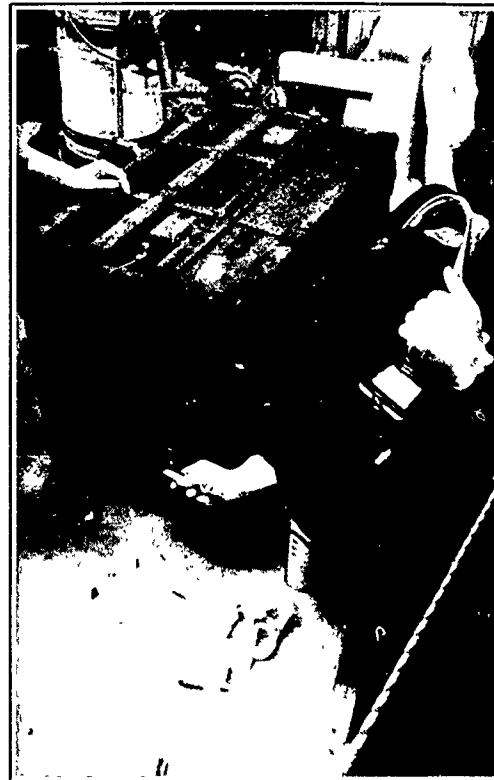
a. Piece of Contaminated Furniture from the 107 E. Stratford Residence. Approximately 20 pieces of antique mahogany furniture, such as this classic curved-glass china cabinet, were removed from the 107 residence and successfully decontaminated for the owner.

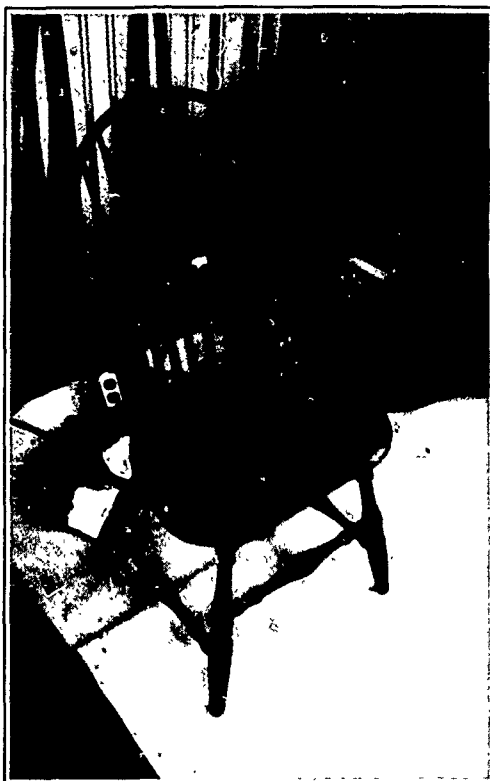
c. Chair with Marred Finish Following Decontamination. All pieces of decontaminated furniture required refinishing afterwards. This was left up to the owner to do.

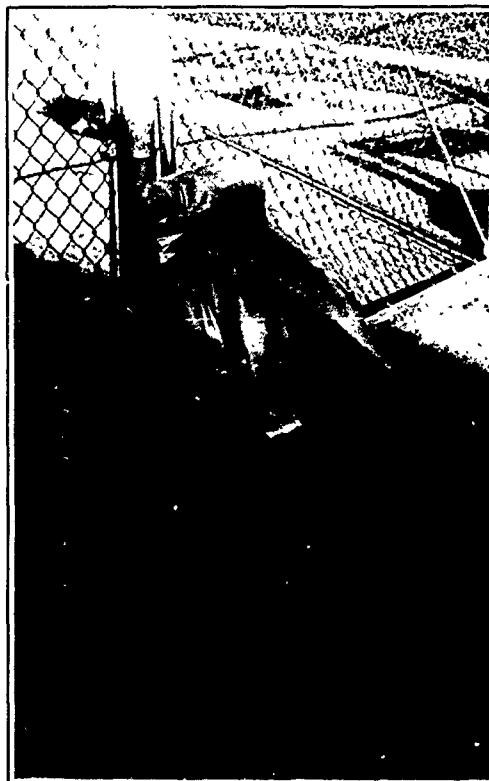
d. Decontaminated Chair Wrapped in Plastic and Awaiting Delivery to the Owner. Prior to being returned to the owner, all pieces of decontaminated furniture were individually packaged as shown.

Fig. 6:5 - Furniture Decontamination.
Sept. 1988.

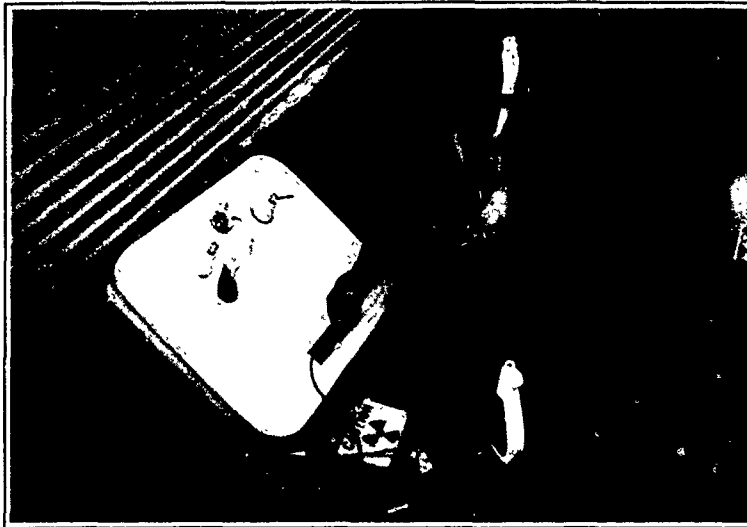
Fig. 6:6 - Contaminated, Antique Porcelain-Sink.
This was one of the few fixtures/furnishings inside the 107 residence that could not be decontaminated. Alpha radiation emitters were deeply imbedded in the porcelain at the location where the alpha probe is shown. After days spent unsuccessfully trying to remove the contamination, the sink finally trashed as rad waste. Sept., 1988.

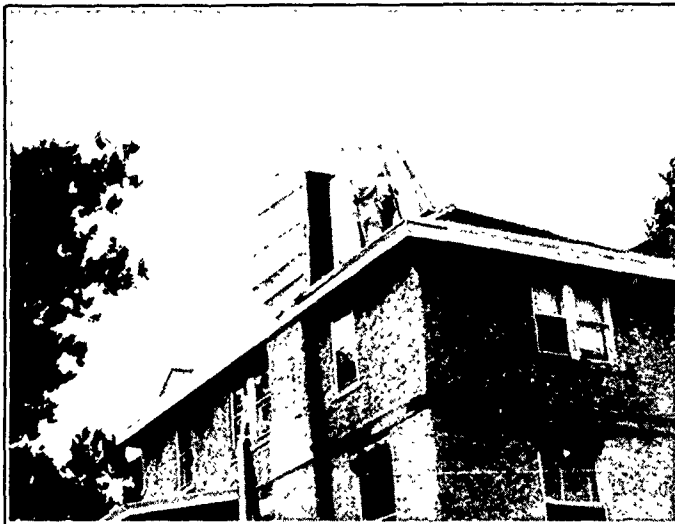
a. Workers constructing sealed containment around the exterior part of the main chimney, 105 side.

Exterior building dismantlement began by removing the two chimneys on the 105 side of the duplex. Survey data showed the chimney bricks to have a radiation dose level of around 5 milirem/hour, so the exterior chimney parts were dismantled within a local, HEPA-ventilated, sealed containment. The loose bricks were dropped down the chimney flue and extracted from inside the house. Following removal of the exterior chimney parts, the roof was draped with a plastic tarpaulin. While this may not have been an air-tight containment, the HEPA vacuum system was able to achieve a condition of negative air-pressure in the work area beneath the tarp. A hole was next cut in the roof from inside the building, and a pole was inserted through the hole to pitch the tarp clear of the roof and provide working space between the tarp and the roof exterior. Workers on the roof exterior would then pass dismantled shingles and roofing boards down to other workers on a scaffold inside the house. Once the rubble was inside the house it was frisked by RADCON technicians to determine if it could be disposed of as clean or radioactive waste. October, 1988.

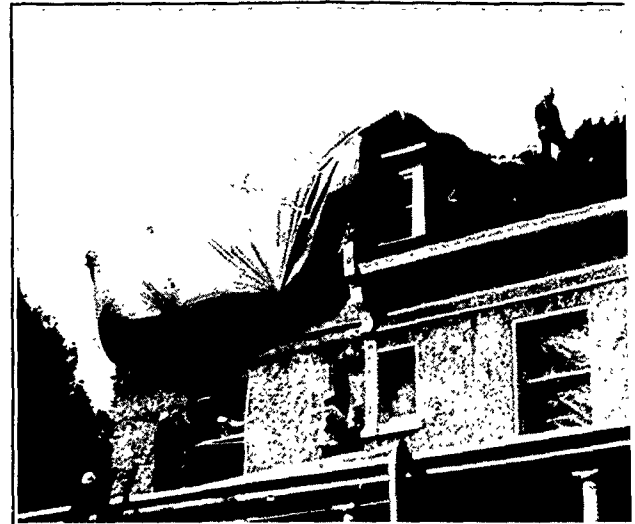
b. Placing the plastic tarp containment structure over the roof of 105 side.

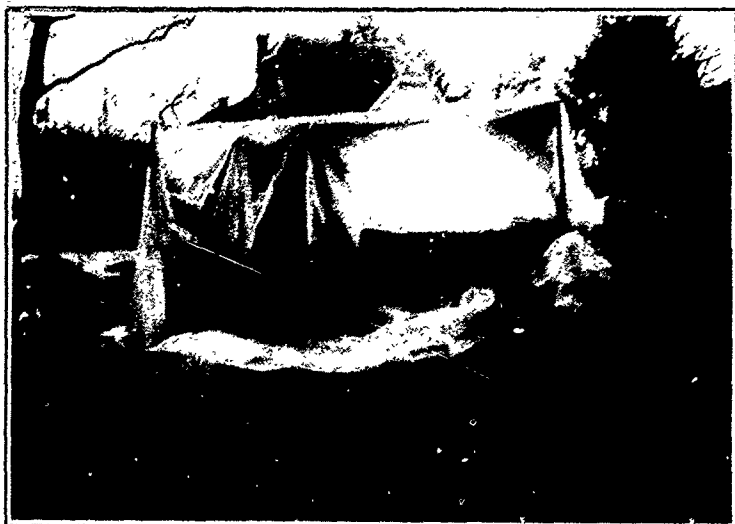
a. Containment structure over the radium processing room in the rear of the remaining part of the 105 residence. Photo taken facing east.

Because of the relatively high radiation levels (greater than 100 micro-R/hour) the 105 basement was dismantled within a sealed containment consisting of a double layer of plastic sheeting draped over a light wooden frame. The containment was HEPA ventilated with the 2000 cfm unit. Dismantlement began in the radium processing room. Rubble was passed to workers in the packaging containment located in one of the center rooms of the basement and placed into a B-25 box. When a B-25 box was fully loaded, the packaging containment was sealed off from the rest of the basement with plastic curtains, and the box was vertically hoisted out of the containment through a hole in the basement ceiling. February, 1989.

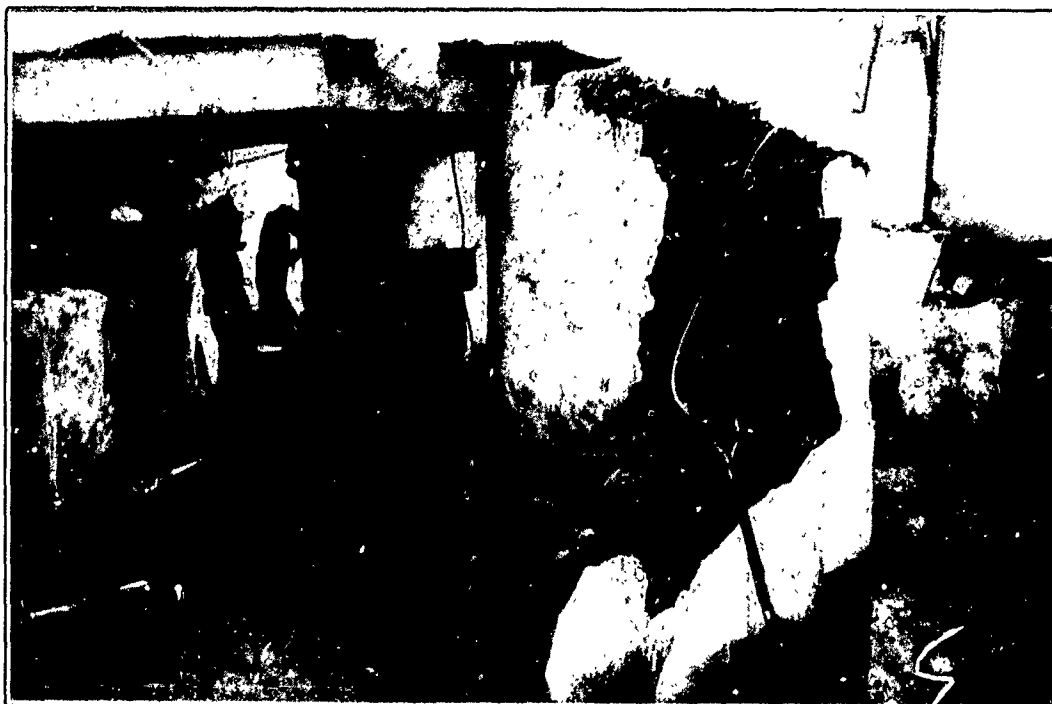
b. Photo taken inside the 105 basement containment, standing in the area of the dismantled radium processing room, facing south toward the packaging containment in the basement center (plastic curtain).

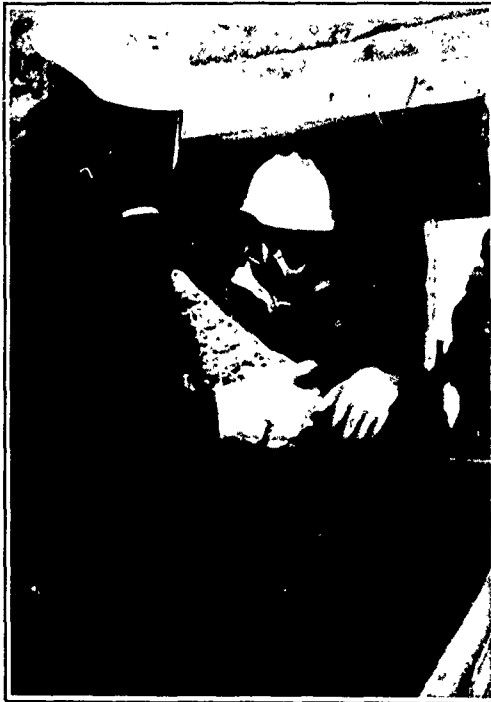
c. Rubble being passed to a worker filling a B-25 box in the packaging room. For dismantling the 105 basement, the laborers substituted full-face or powered-air half-face respirators for their air-hat respirators, as these had a higher factor of safety.

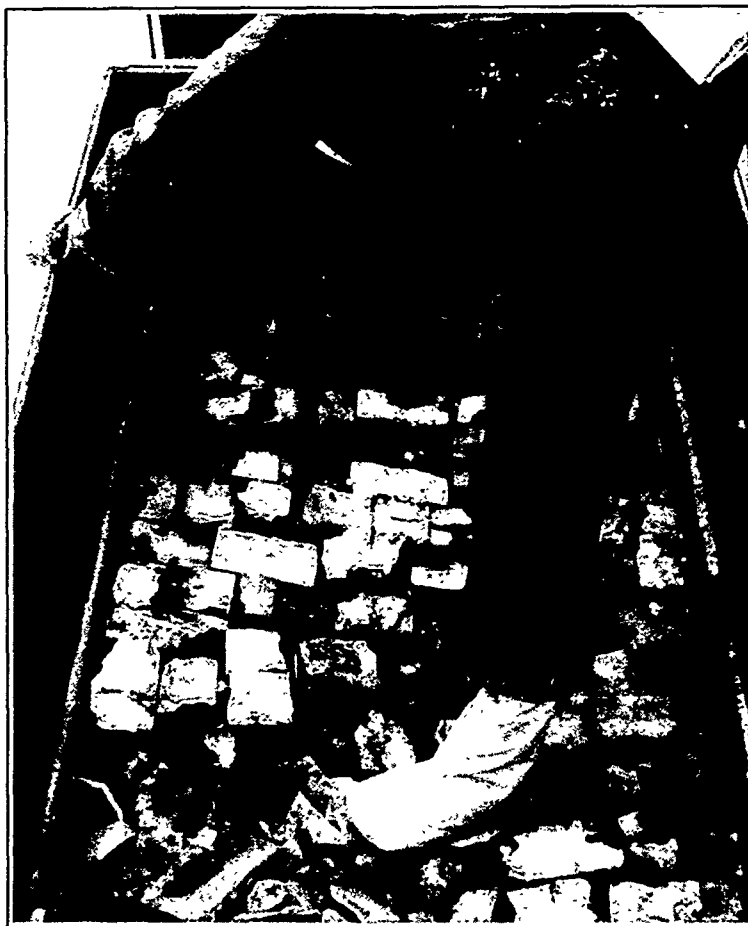
Fig. 6:10 - Brick Rubble Meticulously Packaged Inside a B-25 Radioactive Waste Container.

The unit of payment to the Contractor for radioactive waste disposal was the "ton." However, the cost to the Contractor for radioactive waste disposal was by volume. It was therefore in the Contractor's financial interest to pack as much weight into a 94.3 cubic-foot B-25 box as he could. Pursuant to that end, bricks from the dismantlement of the chimneys and exterior walls of the house had to be laid end-to-end, layer-by-layer, in order for the box to hold the maximum number possible. Taking time to neatly package the bricks did not hold up the progress of dismantlement. It usually took RADCON longer to frisk a load of bricks to conclude that they were all contaminated than it took the laborer inside the packaging containment to neatly pack the load. October, 1988.

shipping manifest, and finally making arrangements with a trucking company to haul the boxes away. Photographs of these activities appear in Figs. 6:10 and 6:11, at the end of the Chapter.

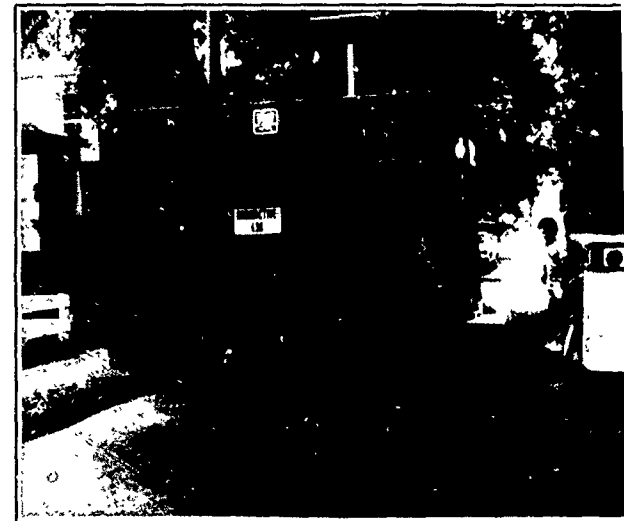
e. Boxes were next affixed with a label reading "Radioactive L^S Specific Activity), and the boxes were loaded onto a truck for s Loading took place just outside the jobsite security fence on N

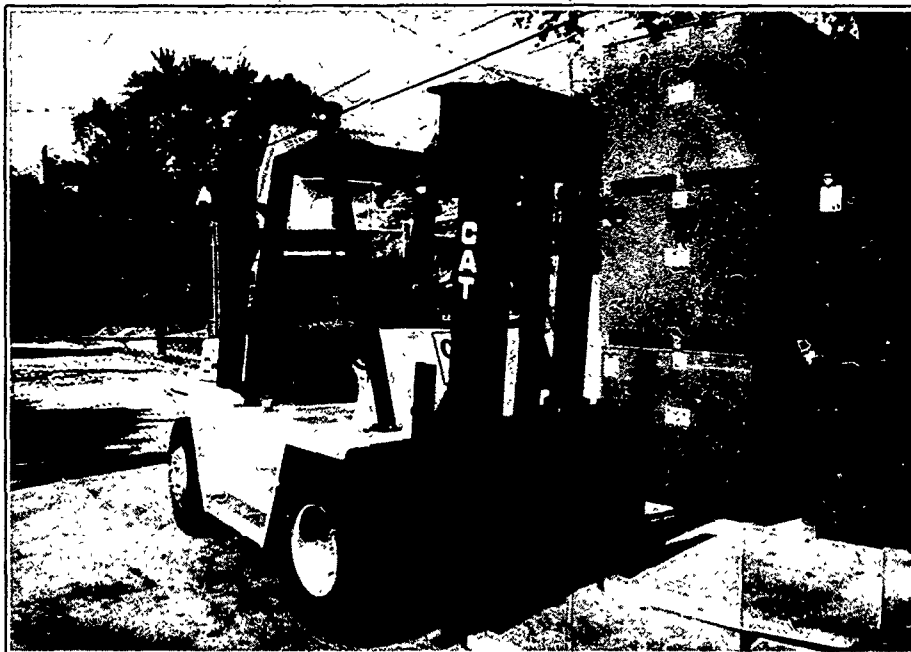
c. Boxes awaiting shipment were stacked on E. Stratford Avenue, in the small area between the security fence. This was the only available non-contaminated area on the jobsite, as the OSF offices took up all remaining space. The storage area could accommodate up to 20 boxes awaiting shipment. The pace of dismantlement was slow, so no bottleneck during building dismantlement, as the pace of dismantlement was slow, the Contractor could pack 20 or more boxes per day. So to prevent the limited storage space from slowing down the pace of work, he had to arrange for at least 5 trucks daily to haul the soil and debris.

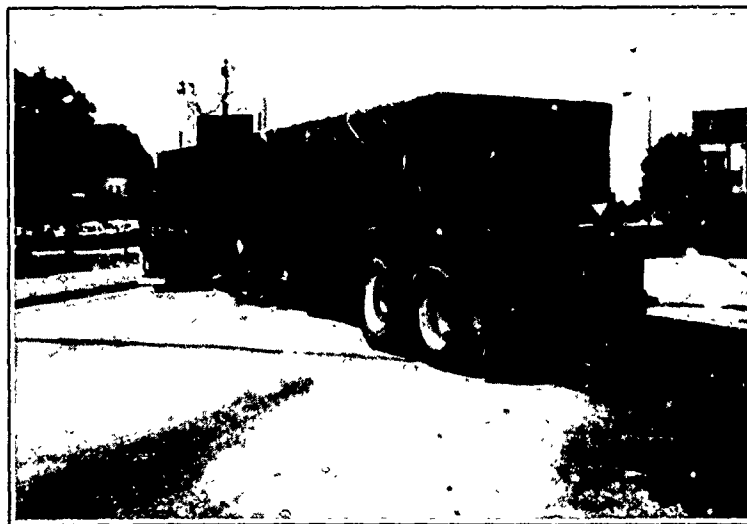
g. With all shipping documents in order, the placarded rad-waste shipment headed out of Lansdowne bound for Utah. 40,000 lbs gross was the maximum weight a truck was permitted to haul. The fact that the truck in this picture has a load of 12 boxes indicates that the boxes contained light-weight rubble from the house. Trucks hauling radioactive soil normally had a load of only 4 boxes weighing around 10,000 lbs. each.

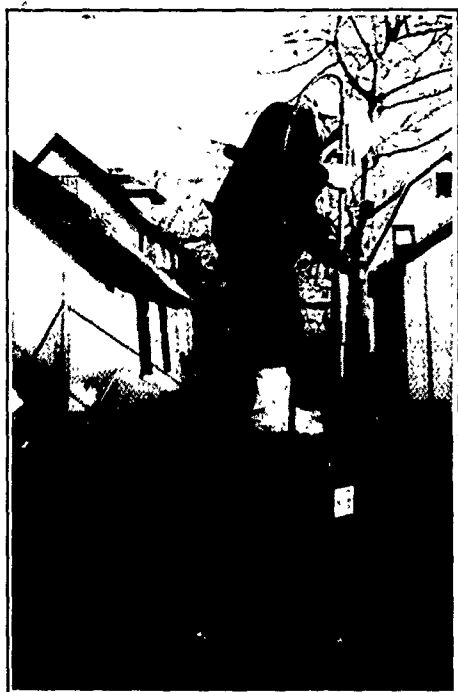
d. About 20% more density could be obtained by compacting soil filling a B-25 box in 12-inch lifts. This was especially important to the Contractor because payment by the Government for disposal was by weight and his costs to the disposal facility were by volume.

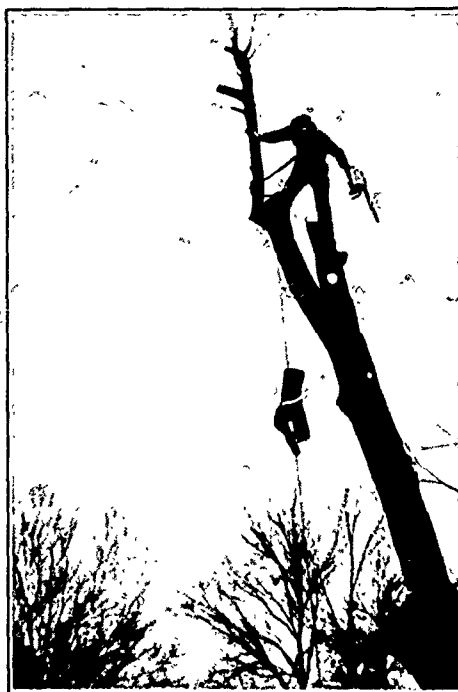
e. Several large trees on adjacent properties were enveloped by the expanding area of the soil excavation and had to be removed. Such trees were replaced for the owners during site restoration, however with nursery stock.

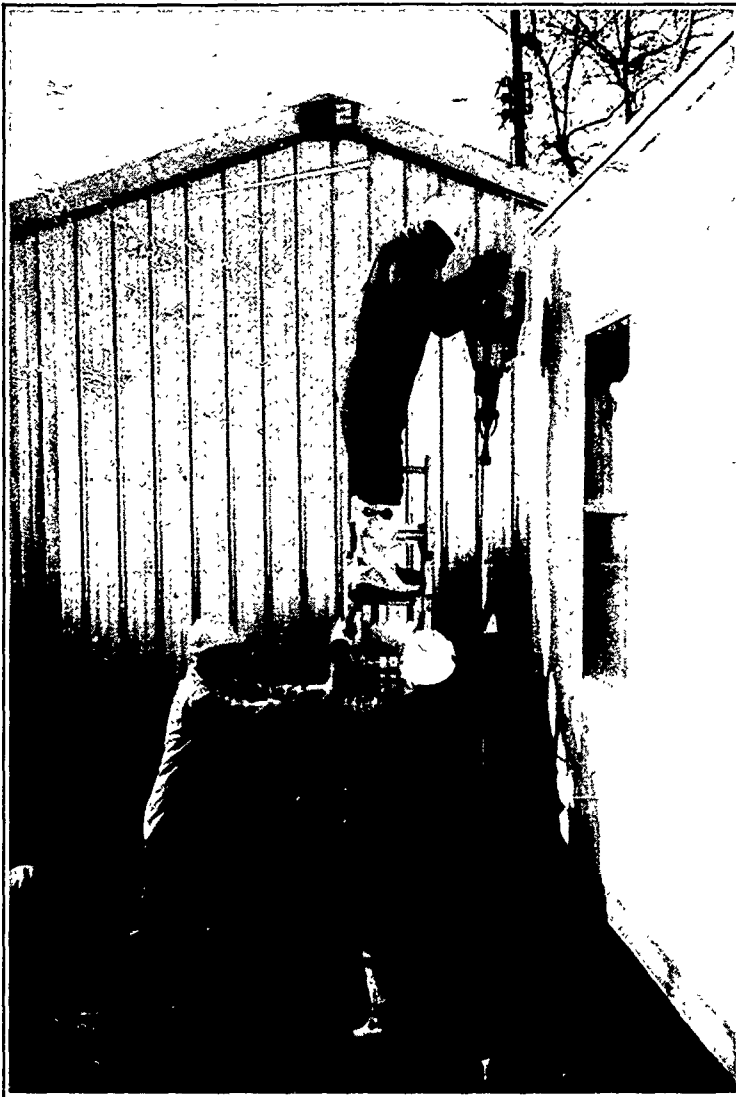
a. Workers driving aluminum conduit tubes in the jobsite administration area. The OSF is in the background; crew trailer is at right. A "Cobra" gasoline powered hammer, manufactured by Atlas-Copco was used to drive the pipe. A steel penetrometer point on the penetrating end of the pipe facilitated penetration and kept soil out of the inside of the pipe. The pipe in this photograph is being driven through the pavement of E. Stratford Avenue, in the vicinity of the sewer lateral from the 105 residence. Subsequent subsurface logging indicated that there had apparently been considerable exfiltration of radioactive contamination from the lateral. This was confirmed when the area was excavated.

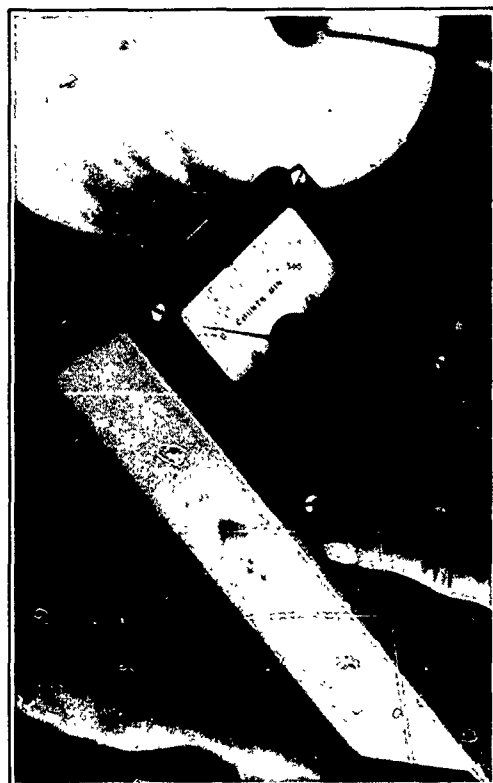
c. Ludlum 2220 scalar/ratemeter being used to make a count of subsurface radioactivity. Counts were usually made for a period of 1/10 of a minute. Using the sodium iodide detector, a count rate of 800 cts/min corresponded to a Ra-226 concentration in excess of clean-up criteria. The count rate of 380 cts/min shown on the Ludlum in this photograph indicates that the soil is not contaminated.

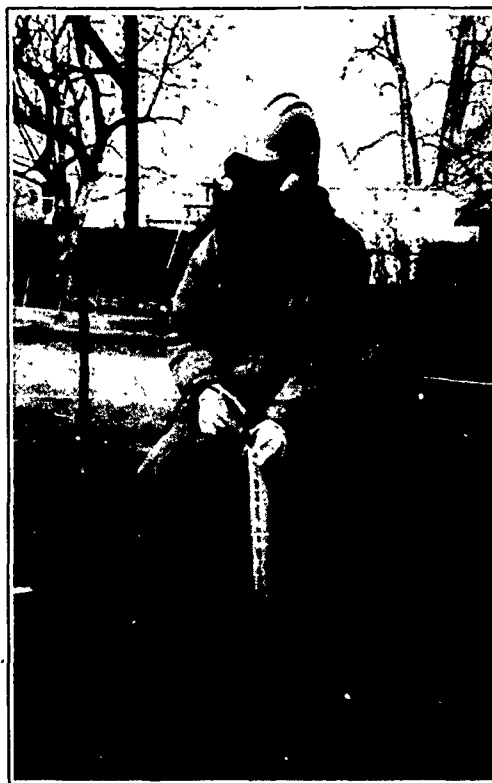
d. Health physicist from Argonne lowering the sodium-iodide detector through one of the pipes driven into the ground. The cable is marked off in 1/2-foot increments and runs to the Ludlum 2220 scalar/ratemeter being operated by a second health physicist who recorded the radiation counts. The stick-up on the pipe in the background indicates that it hit something solid in the subsurface and could not be driven its full length of 10 feet. This was a frequent happening, as the soil contained numerous boulders. It did not, however, detract from the accuracy of the survey.

When the initial contract estimate of 1000 tons of contaminated soil was exceeded during the first several days of soil excavation, it became necessary to obtain additional funds to pay for the overrun. To that end, Argonne National Laboratory was tasked to do a comprehensive radiological survey to determine the amount of contaminated soil and hence the amount of additional money that would be required to pay for its removal.

By this technique, Argonne was able to predict the subsurface contamination profile and estimate remaining quantities, which turned out to be short by only about 100 tons. Considering that around 4100 tons of contaminated soil were excavated, that is a highly accurate estimate. December, 1988.

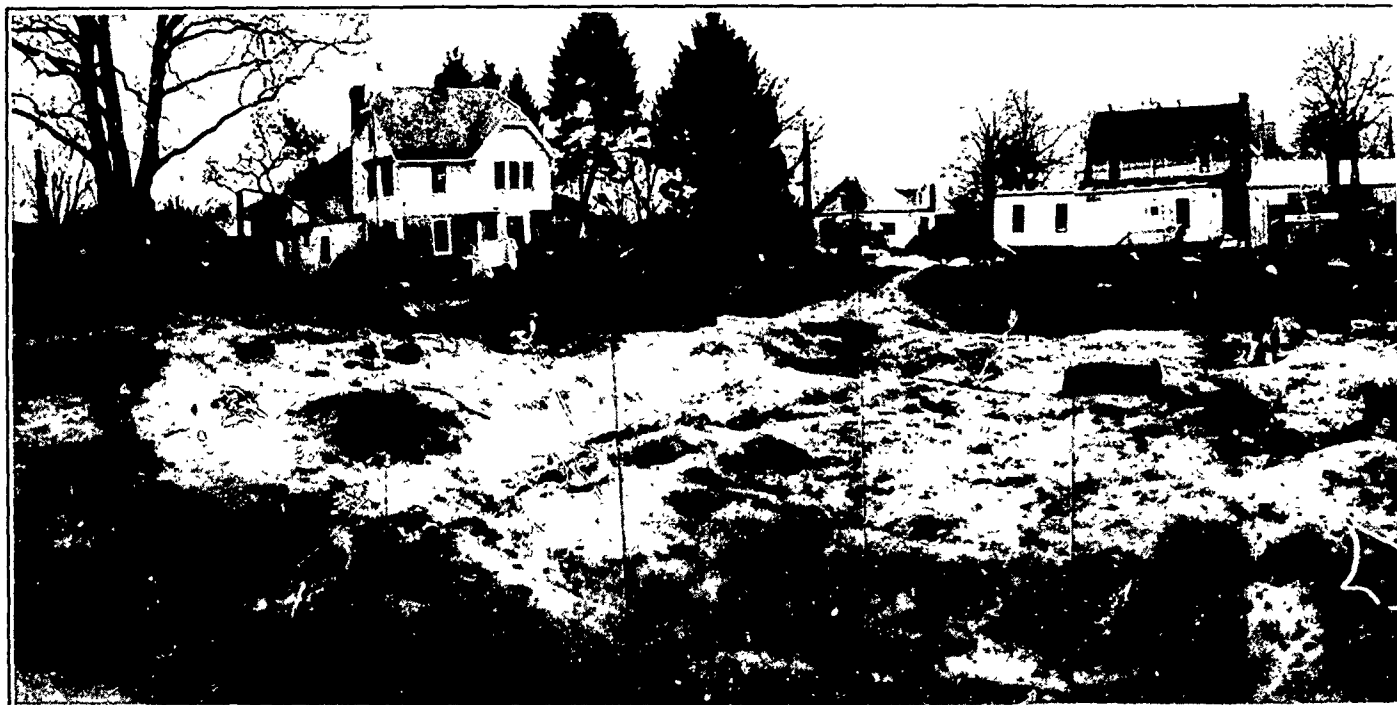
Fig. 7:4 - Jobsite Facing South from the 112 E. Stewart Property Near the End of the Final Phase of Soil Excavation. The photo mosaic is taken from the same perspective as Fig. 7 above. The two garages and the 105 basement are gone, along with approximately 4100 tons of contaminated soil. The irregular excavation grade reflects how the radioactive contamination was distributed in the subsurface. March, 1989.

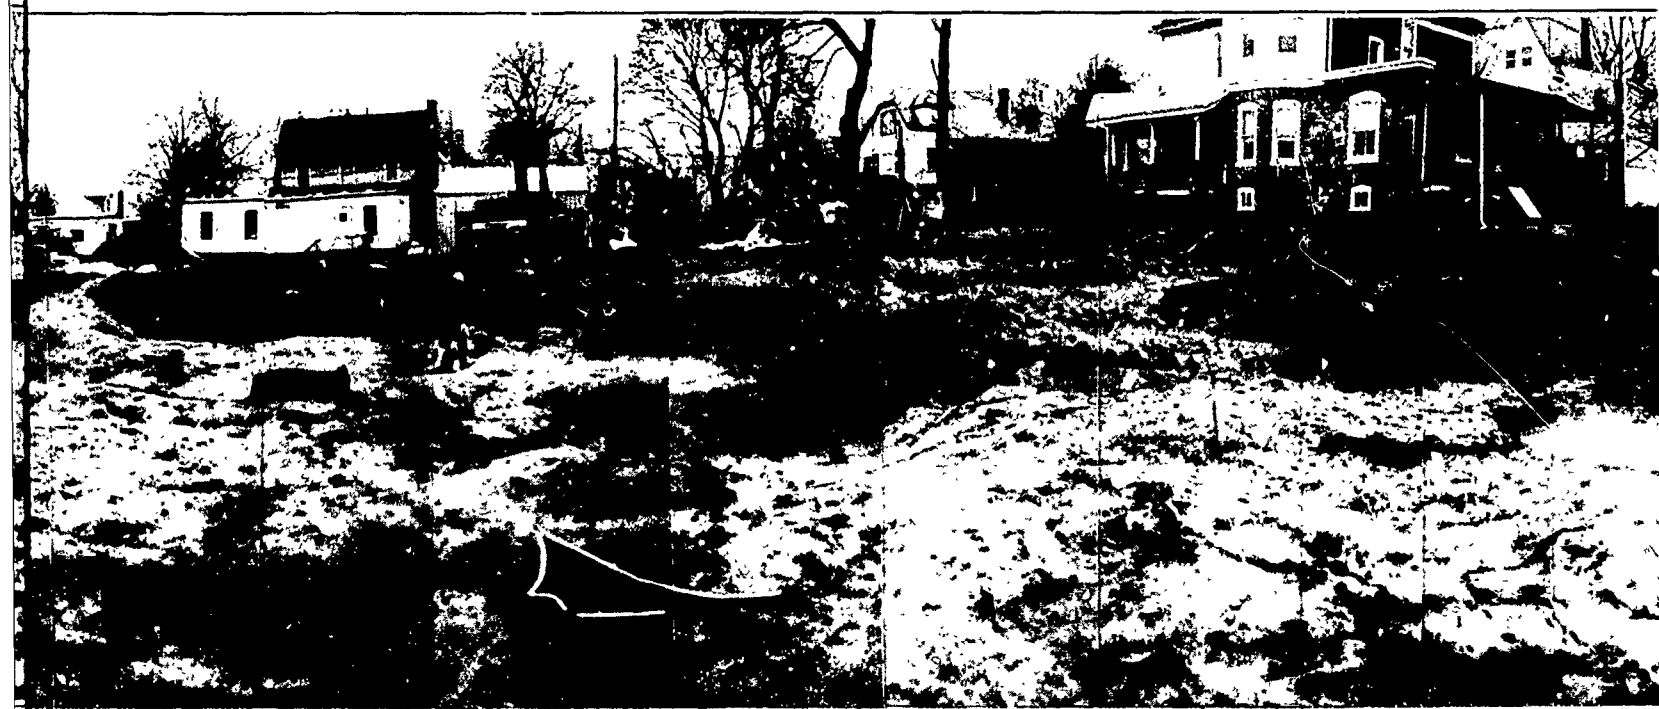
Fig. 7:3 - Jobsite Facing South from the 112 E. Stewart Property Prior to the Final Phase of Soil Excavation.

The soon to be dismantled 112 E. Stewart garage is in the right foreground, and the contaminated 107 E. Stratford garage is in the left foreground behind the tree. The containment structure in the center foreground covers the 105 E. Stratford basement where dismantlement is underway. February, 1989.

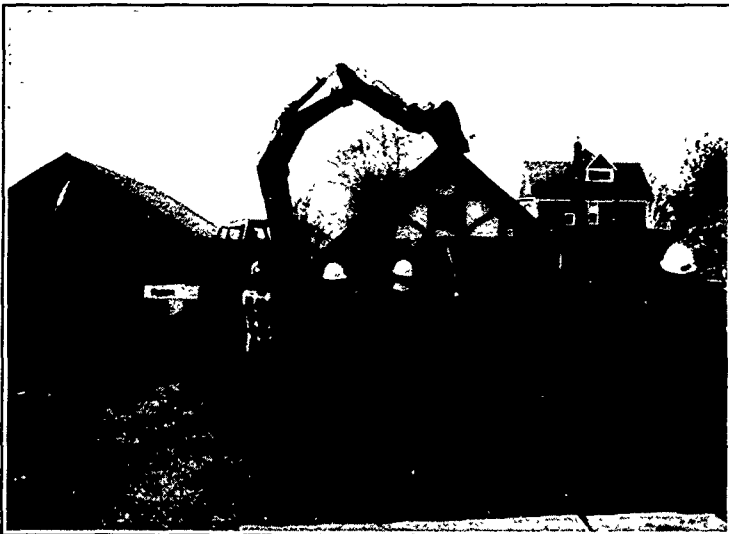
a. Garage at 110 E. Stewart Ave., underneath which lay the 17th Century root cellar used as a burial site for radioactive waste. The structure is shown being demolished by a Poclain MD-80 track excavator as a prelude to excavating contaminated materials underlying it.

One of the biggest surprises of the remediation effort was the discovery of an old stone foundation or root cellar beneath the garage at 110 E. Stewart Avenue. The overlying garage was not contaminated, but it had to be removed in order to access contaminated soil that was known to underlie it from the findings of the Second Agonne Subsurface Investigation. In the process of excavating that soil, the root cellar was exposed.

The existence of the root cellar was unknown even to lifelong residents of the neighborhood. It was filled to the brim with radioactive garbage in the form of ashes, broken laboratory apparatus, and early 20th Century glass bottles. The 11-foot deep cellar was ascribed by the Baltimore District archaeologist to the 17th Century Swedish settlement on nearby Darby Creek. March, 1989.

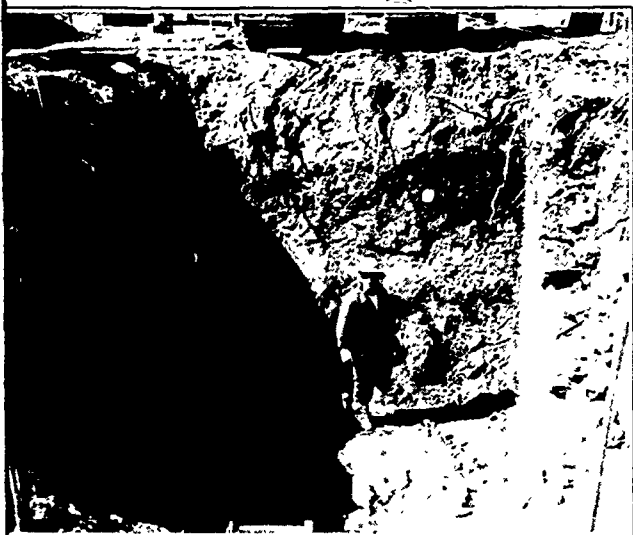
the 17th Century root cellar after removal of the radioactive material that had filled its 11-foot high walls to the top.

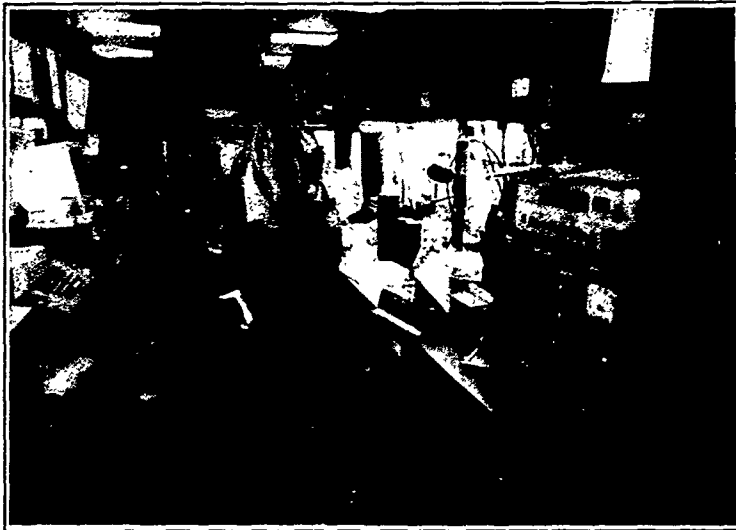
a. Health physics technician from Argonne National Lab preparing a Marinelli beaker inside the Government's mobile field laboratory located on the jobsite.

The procedure employed by ANL was to pack the verification sample into a Marinelli beaker. The configuration of the Marinelli beaker allowed the sample to virtually surround the detector, permitting the maximum radium disintegrations to be counted. It was the limitation of field RADCON's instruments that they also picked up a lot of extraneous radiation from sources other than radium. That made quantification of radium activity in the soil by field RADCON inconclusive and necessitated the more accurate spectroscopic analysis for certifying an area to be free of contamination. March, 1989.

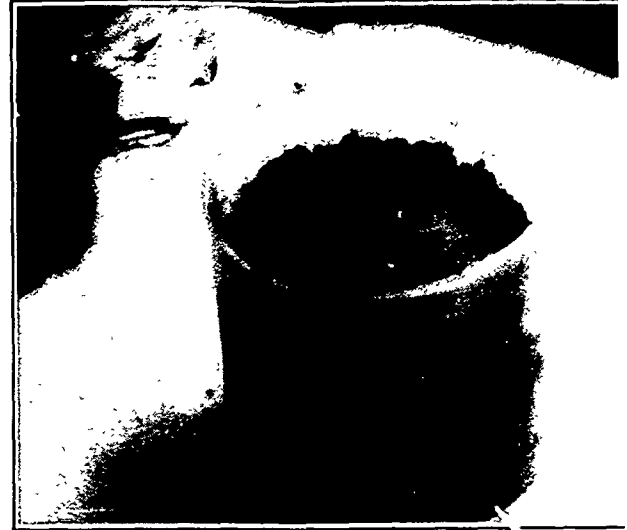
b. Partially filled Marinelli beaker showing the hollow cylinder which fitted around the gamma detector to practically surround it with the soil sample being analyzed.

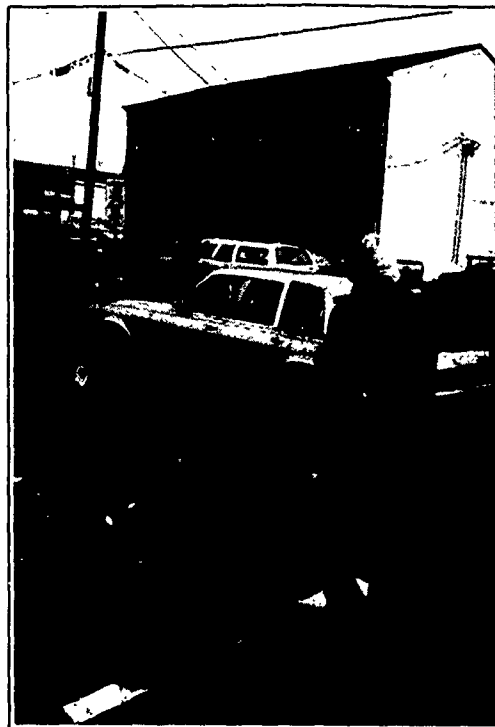
b. Cork and fishing line were snagged and retrieved at the downstream manhole.

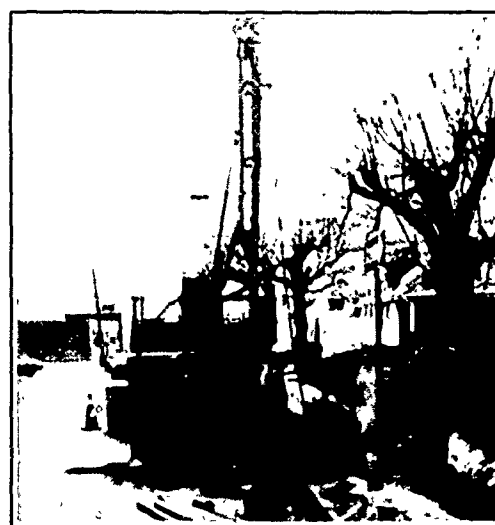
g. A drilling rig was brought in to obtain soil and rock samples around the anomaly.
